**Waytemore Castle mound limestone blocks.** Identification: CP WCP22 064–069 (6 stones) MOLA ref S00243516.

## Summary

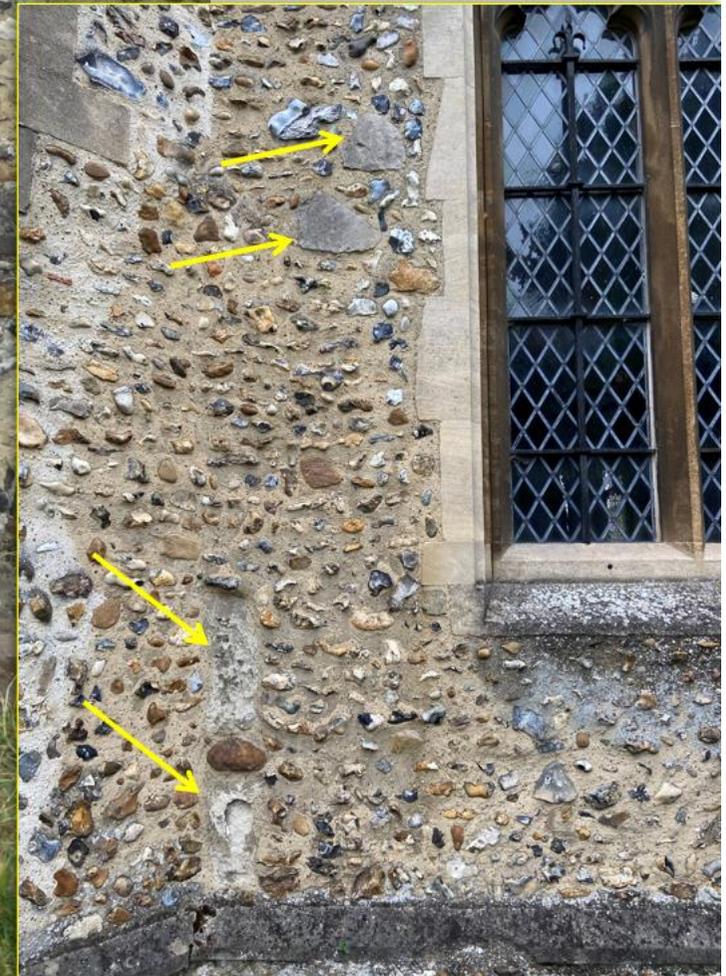
**Fig. 1: The six mound stones** (064-069, left to right) arranged in front of the south wall of St Michael's church. In the angle, vertically above 064, light-gray limestone blocks and a rounded dark brown cobble are visible in the wall. A darkened, shaped, horizontal limestone string course is seen too. **The insert** (right) shows more of the wall above the string course with limestone blocks arrowed; the oval brown stone is also visible; the lower arrow indicates a crumbling limestone block.

- The comparisons with St Michael's church fabric were made mainly on its south side, west of the porch, on Saturday 15<sup>th</sup> July 2023; weather good apart from a brief shower (see Figures 1 & 2).

- The main walls are made of 'field stone' which is largely flint but includes other local (e.g. Hertfordshire Puddingstone) and 'exotic' pebbles derived from glacial till and associated deposits. There is some mortar within the field stone infill and also remnants of a mortar render which would once have covered all the walls between the limestone quoins, doorways, windows etc. Also within the wall infill, particularly near internal corners, are some larger blocks (often friable – generically termed chalk rock or clunch), of a grey limestone. These are of similar size to the mound limestones – see Figure 1.

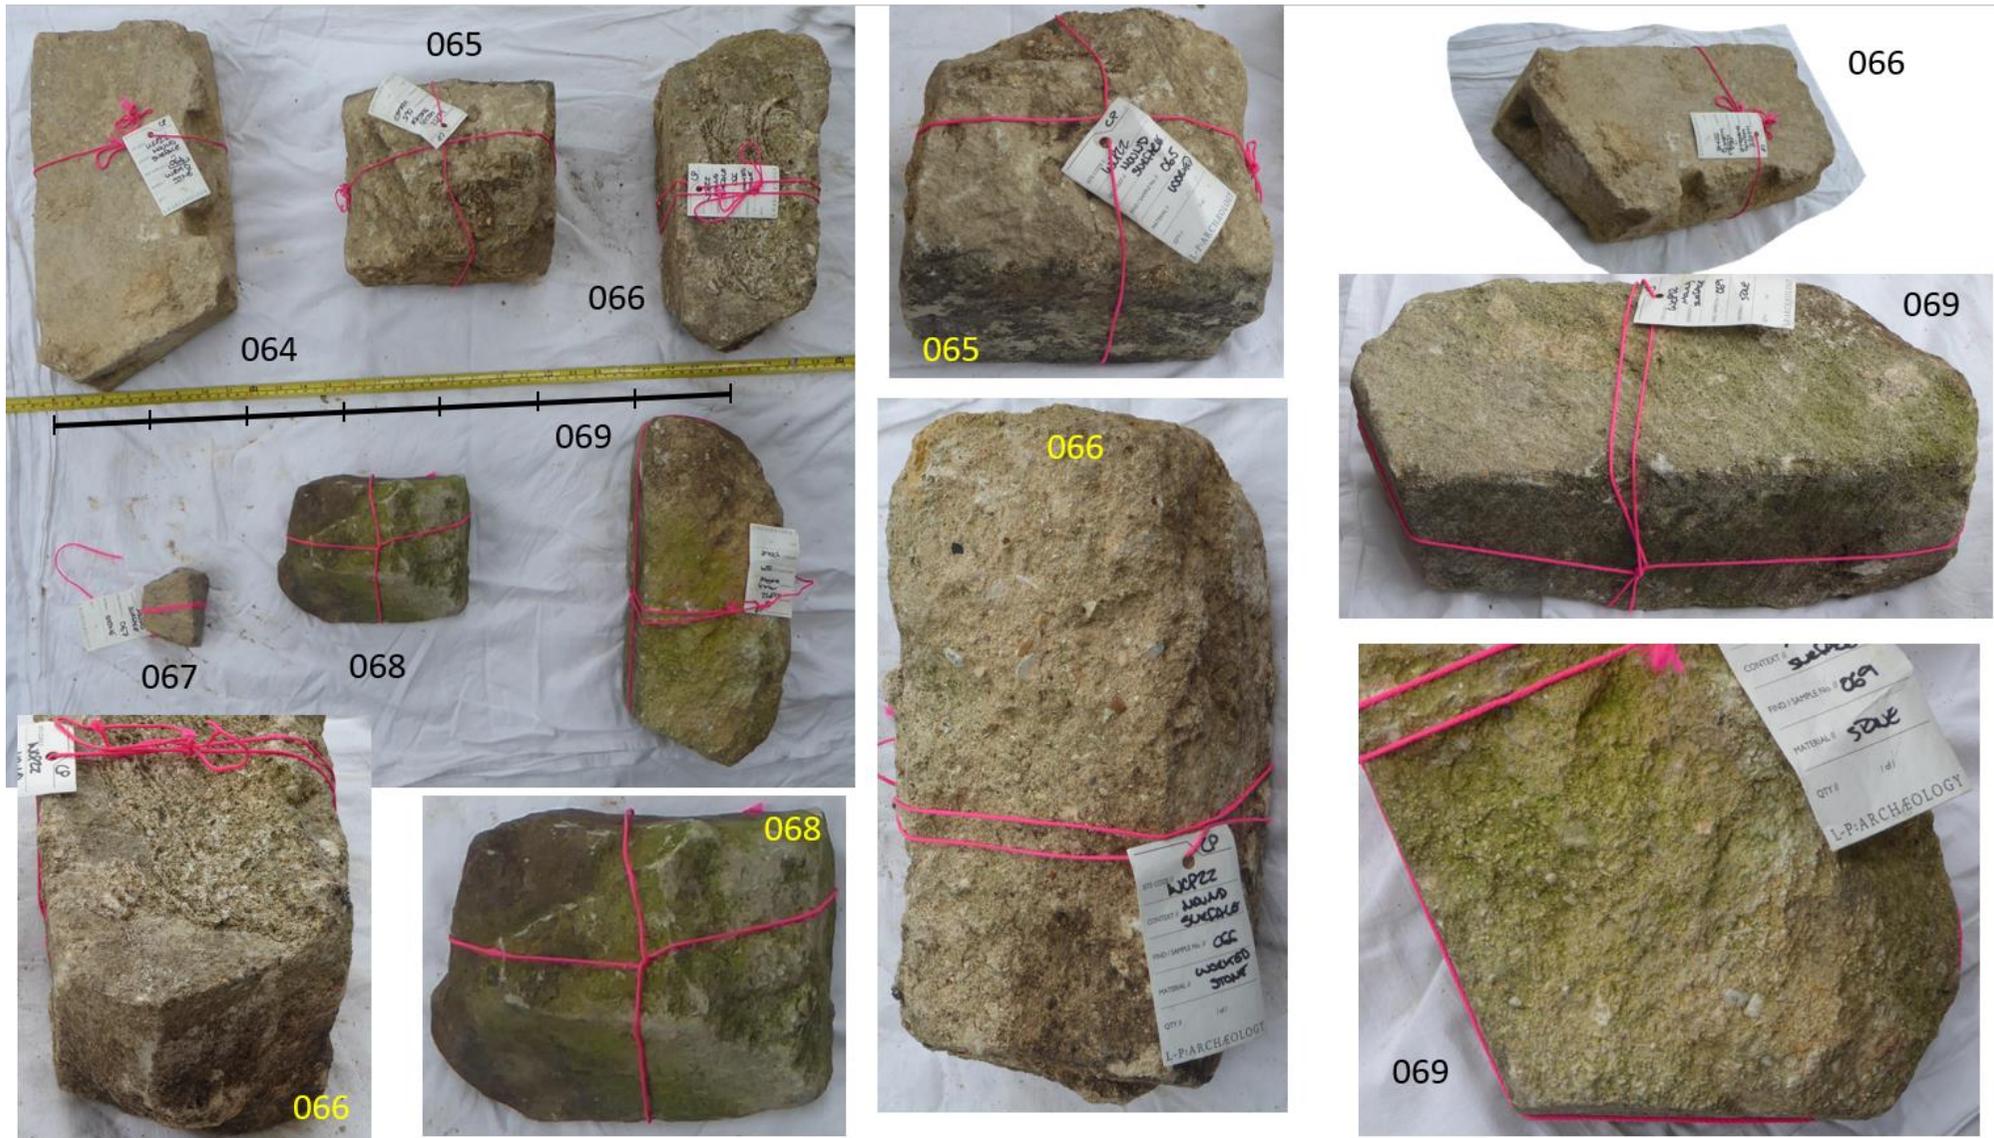
**Fig. 2: The mound stones** in more detail. **Top left:** composite image to show their relative sizes; 70cm scale bar and 10cm divisions. **Anticlockwise from bottom left:** **066** showing sharp bevelled edges and 'oyster shell' mortar pattern. **068** smaller chalky, algal green block with bevel. **066** unworked side showing granular inclusions. **069** with bevelled edge (facing downwards), inclusions in upper surface similar to those in 066. **069** showing chisel patterns in 2 faces behind the bevelled edges (at left). **066** with cut indents at the bevel point and along the side. **065** cuboid stone with darkened surface (facing front) and roughly shaped 'pointy' top. Stone 067 is most likely from the flint rubble.

- The best shaped block (064) is 'cleaner', lighter in colour (no algal green or brown discolouration), is finer-grained and has indentations perhaps to take wedges or door/window closures (Fig. 2). It may have a patch of white plaster adhering. It's the only block with cut holes or indents. Its fabric resembles 065, suggesting the same source.

- The 3 larger trapezoidal limestone blocks (064, 066, 069) are of similar buff colour; two of them (066, 069) are coarser, look similar (Fig. 2) and have small inclusions; 069 has clear coarse chisel marks angled across two faces. Their flattest surfaces are on opposite sides, indicates that in situ they were stacked. Perhaps a common template was used for shaping them, especially if their dispersal round the mound means they're from different apertures. But skilled masons could have shaped these simpler pieces by eye.

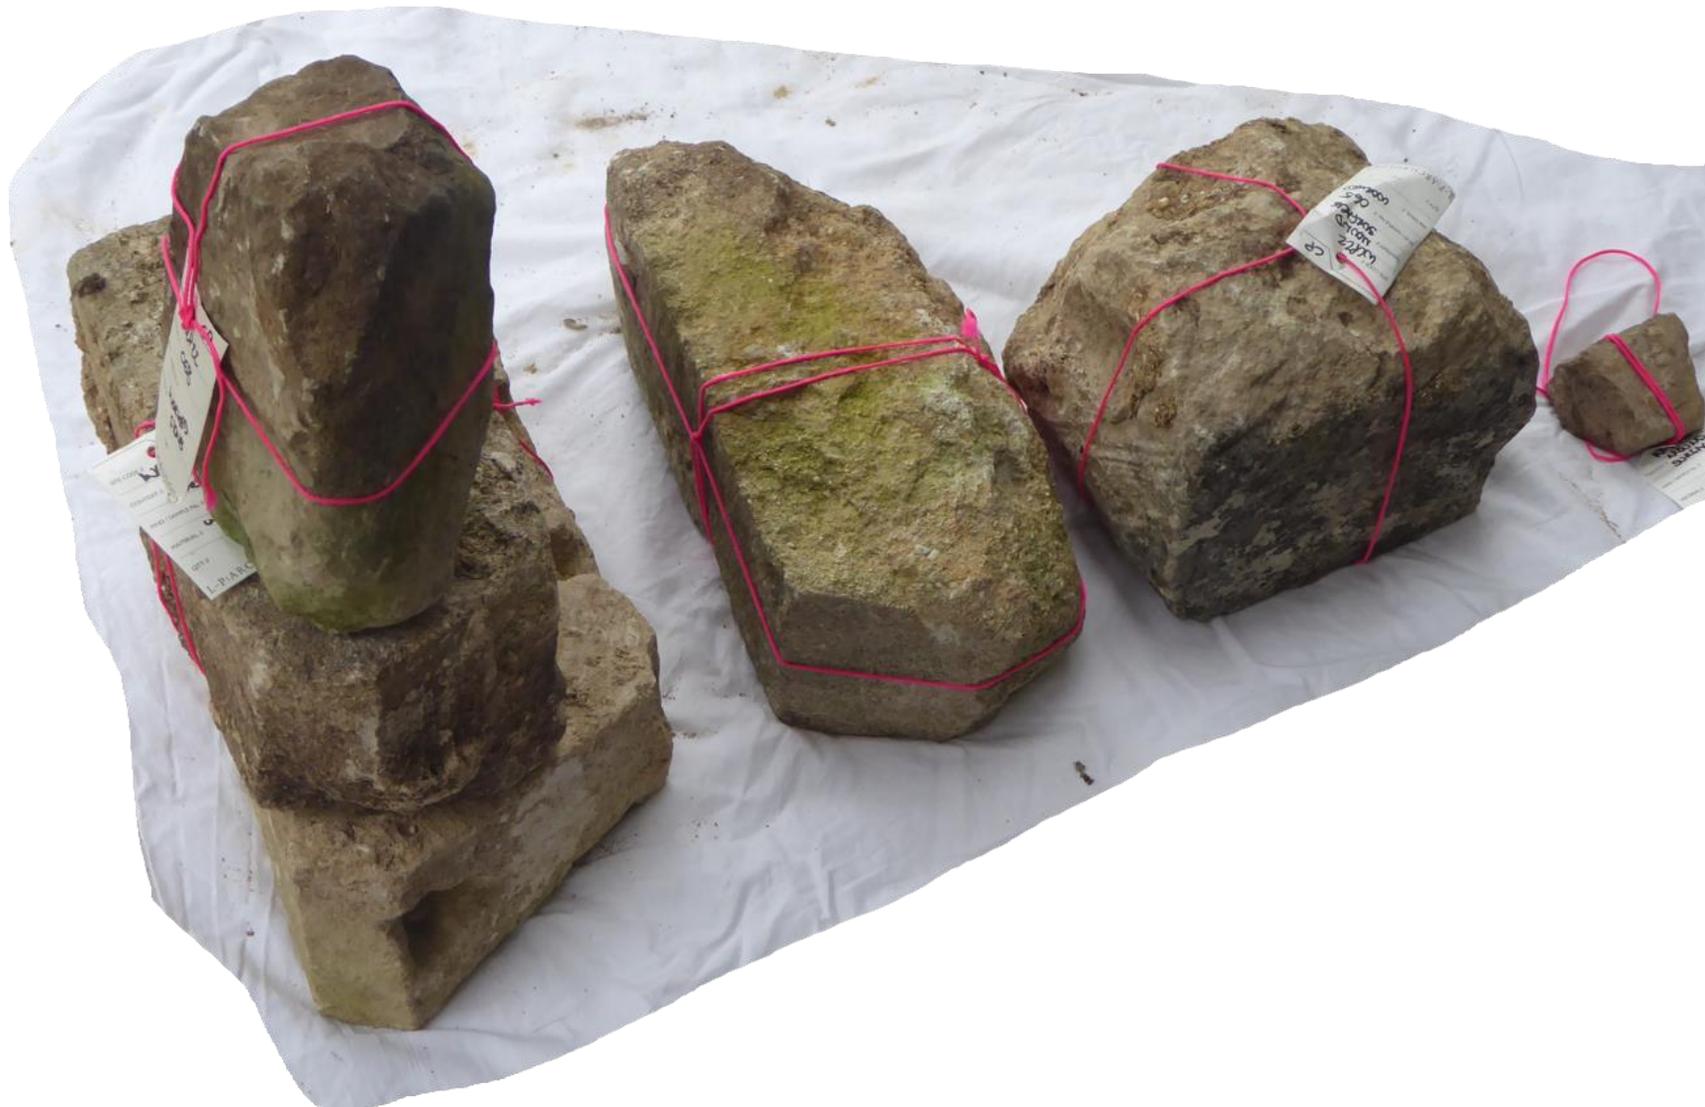
**Fig. 3: The mound stones** shown in a different arrangement. **Left:** stones 064, 066 & 068 (bottom to top) arranged as though on the left side of a window or doorway (looking in).

**Mid to right:** 069 positioned as though on the right of a doorway for comparison, with 065 (cuboidal) and 067 (the smallest).

Perhaps 064 (bottom left), the best preserved with the longest bevel, was from a doorway whereas the others were from windows? However, 069 may be damaged and thus its bevel foreshortened. Nevertheless, the bevel angles appear consistent, possibly templated.

- 064, 066 and 068 could be 'right hand' edges (as if one looks outwards from a doorway), 069 a 'left hand' edge, assuming the flattest faces were placed downwards (but 064 is ambiguous, could be either way) (Fig. 3).
