Comparison of limestone fallen from Waytemore Castle mound and in St Michael's Church.

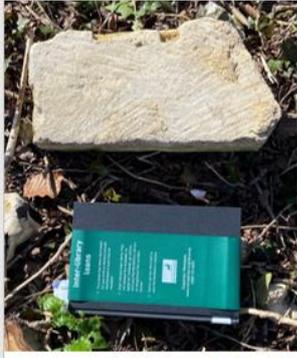
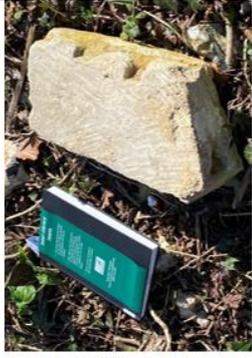
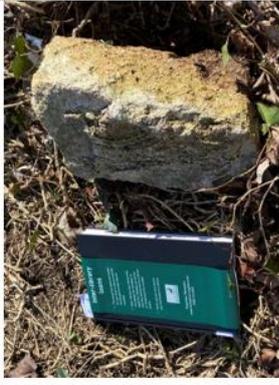
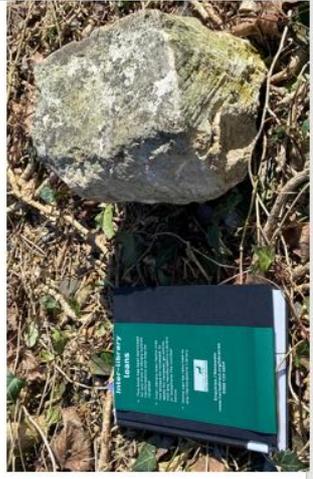
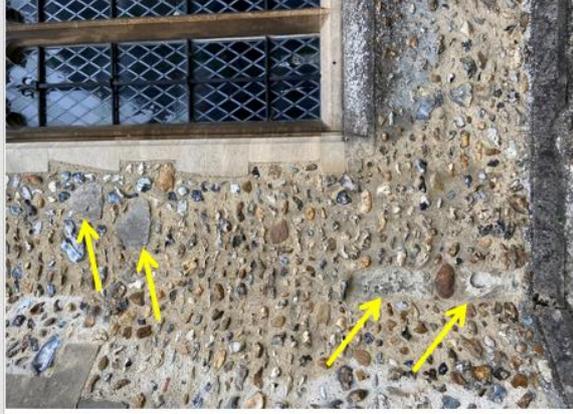
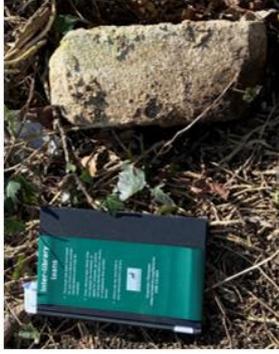
The mound: I've seen only three fallen stones around the mound (see photos). Perhaps Museum of London Archaeology has rescued others. There are also a couple built into the keep's northern wall which may be original. There was also a shaped grey limestone block, apparently a segment of a window embrasure, uncovered in the pit excavated to the southwest of the mound in September 2022. The paucity of castle limestone is to be expected since it was valuable, and was likely scavenged when the castle fell into disrepair and the gaol was sold for its materials in 1649. The fallen mound stones have been shaped (one only roughly) and have chisel marks and traces of mortar. They appear to match the church stones in colour and size quite well, so the hypothesis that the church and mound stones have the same source is not, at least, outlandish. But some of the church stones are weathered in a way that does not match the mound stones, although this could reflect long exposure to the elements.

For scale the book is 23.5 x 16.0 x 2.0 cm

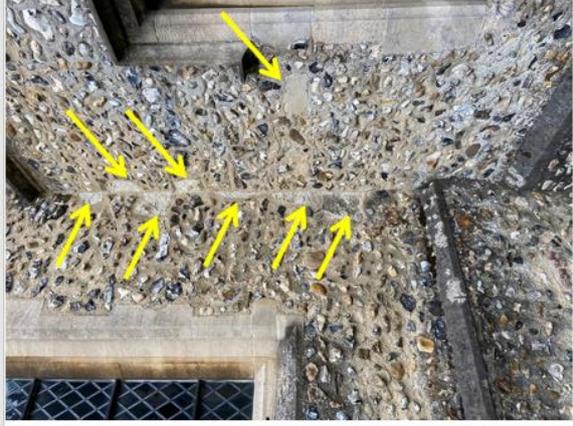
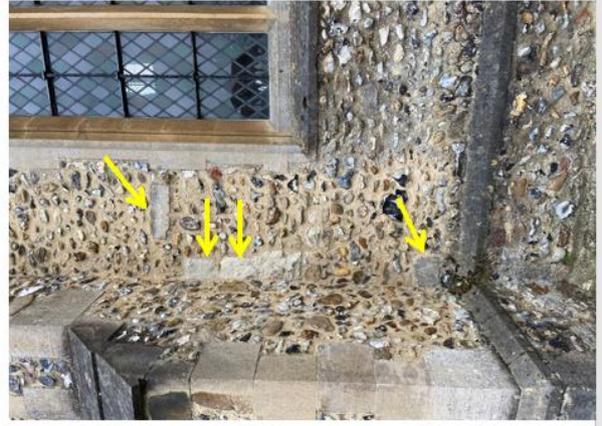
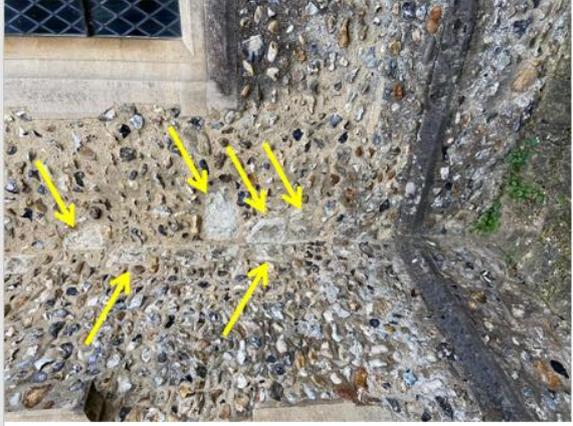
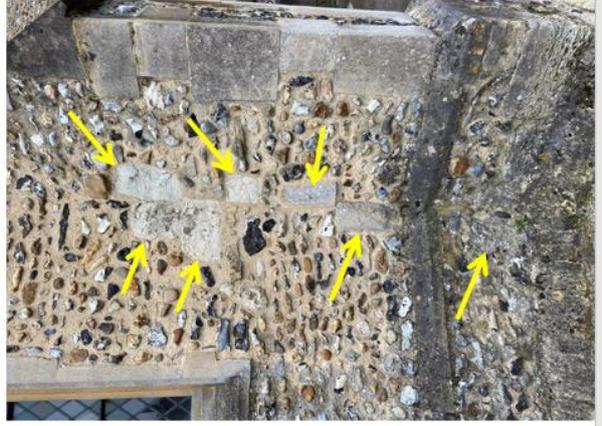
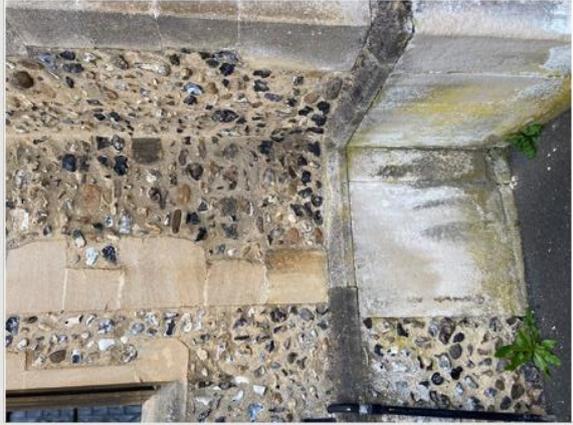
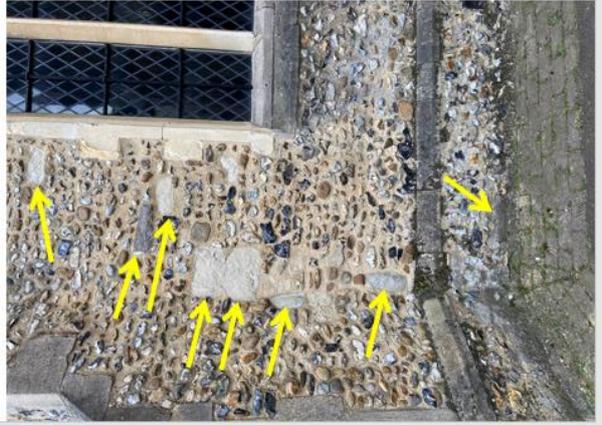
The present church exterior, for many years covered in plaster (removed in 1863), was repaired with flint and mortar in the major renovation of 1868-69, so its overall appearance is now quite uniform. The windows were all replaced using the originals as templates, and the present buttresses may reflect that renovation too. Nevertheless, examining carefully the exterior, some limestone blocks are visible, especially at the building's internal angles (see photos – the limestones are arrowed). The stones therein are mostly grey, not buff like the newer masonry.
